HERMOSA BEACH

Pedestrian Safety Assessment

Issues, Opportunities, and Recommended Strategies

November 2008

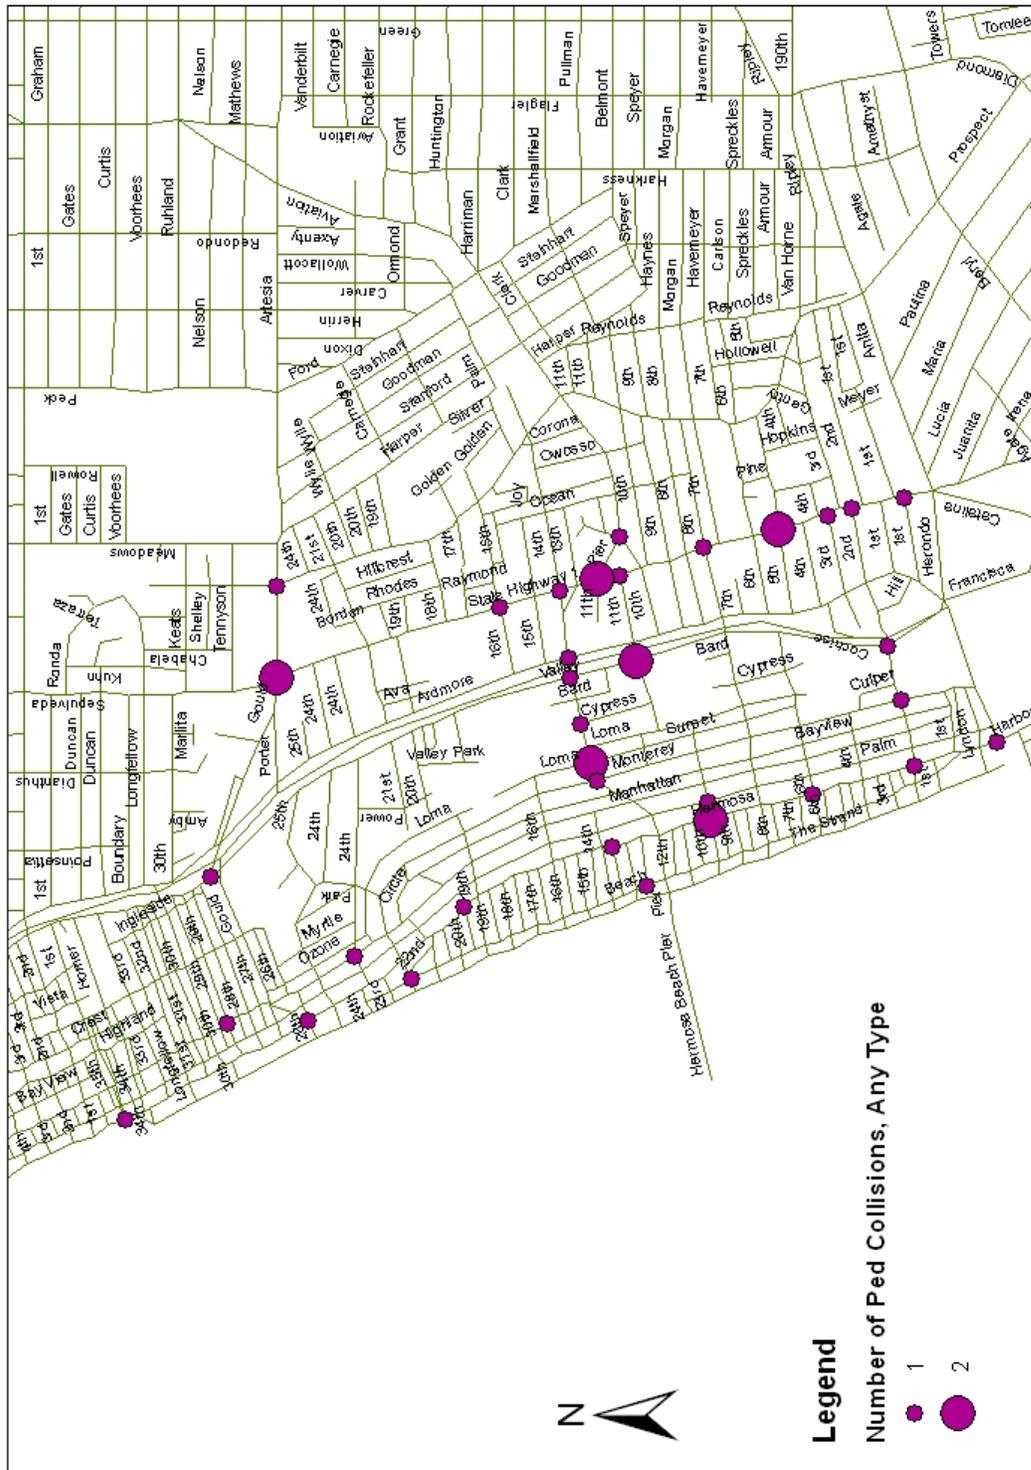
Figure 2-1. Pedestrian-Vehicle Collisions, January 2003 to April 2008

Figure 2-1: Hermosa Beach Pedestrian Collisions 2003-2008

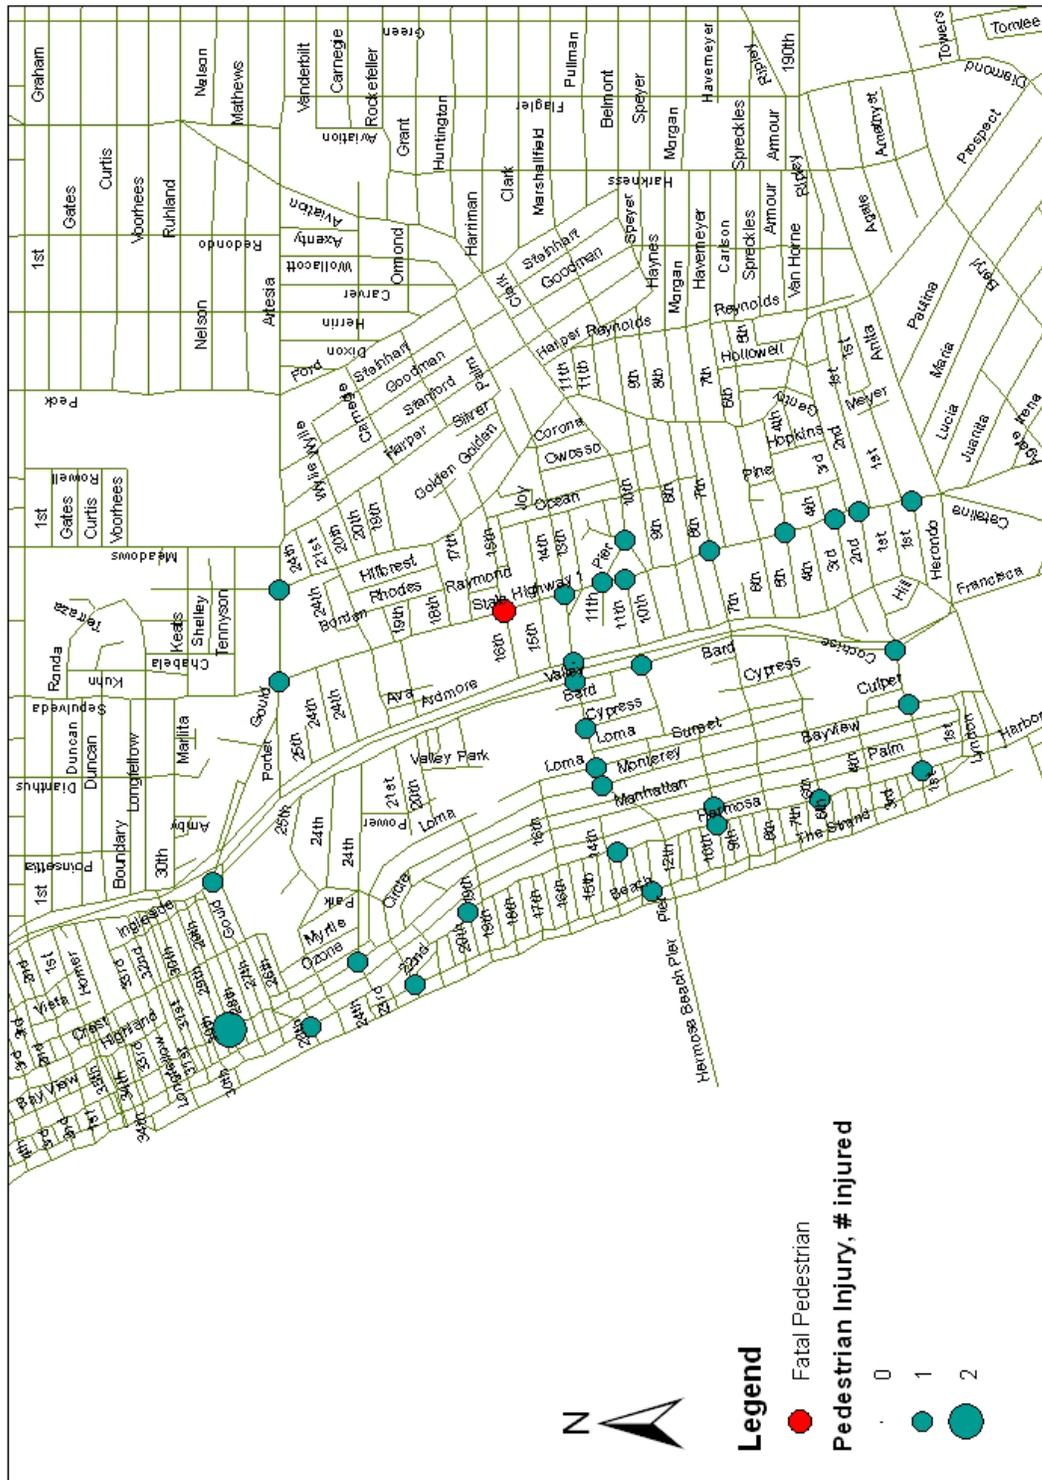
Figure 2-2. Injury Collisions, January 2003 to April 2008

Figure 2-2: Hermosa Beach Pedestrian Collisions 2003-2008

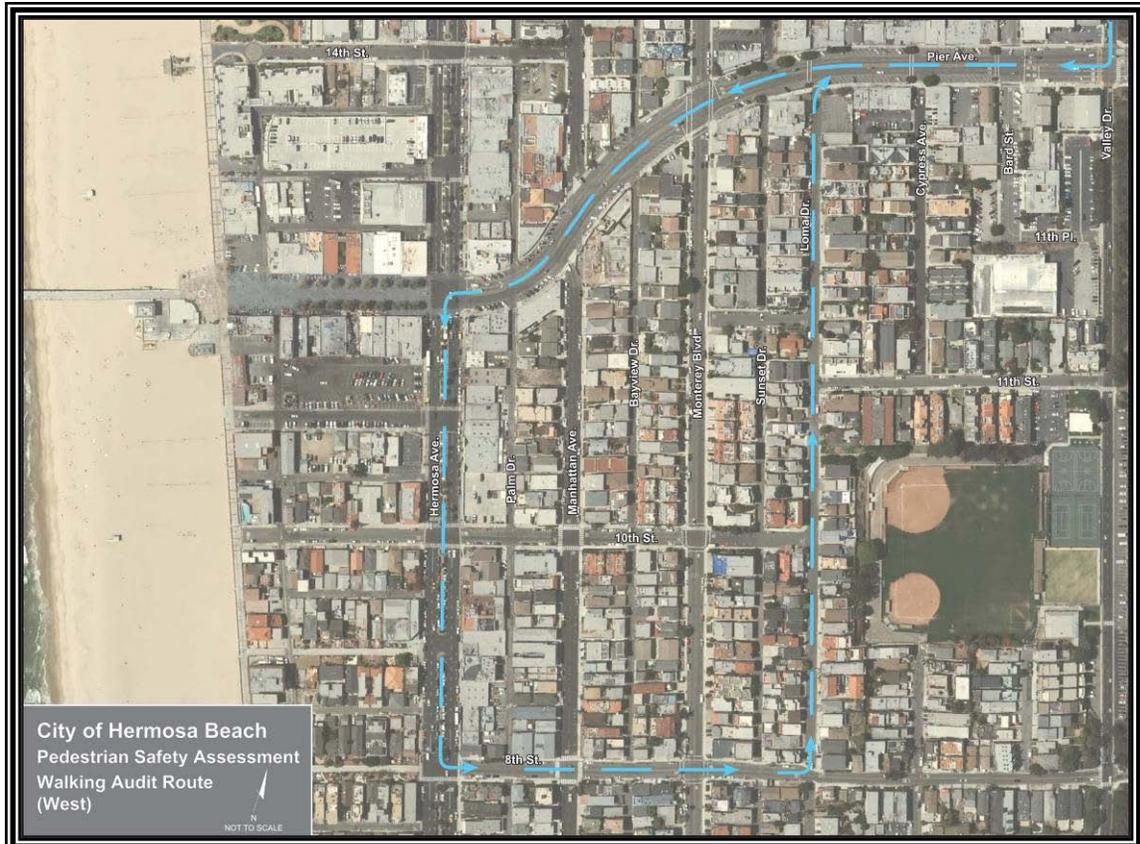
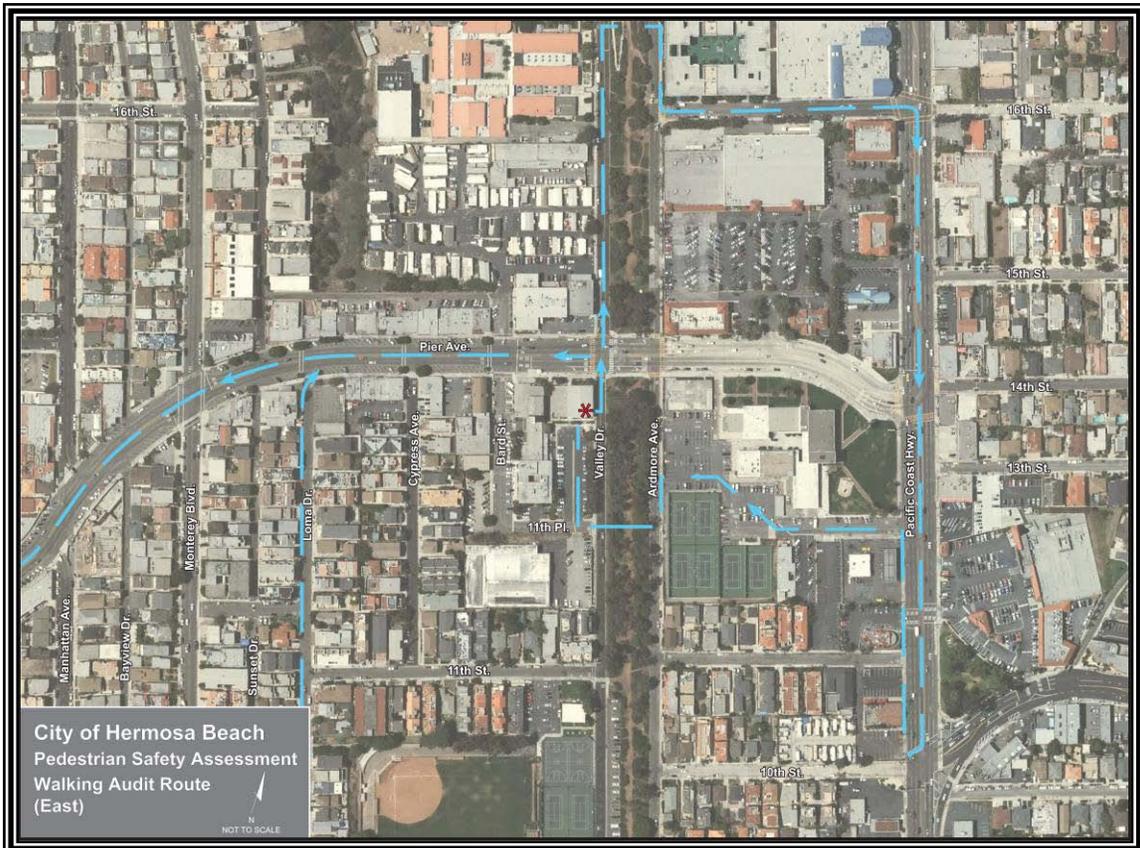
Figure 4-1. Focus Area Locations

The walking audit study area was gleaned from the above criteria and was defined by a loop route consisting of several segments. For purposes of the recommendations, each segment was identified as a separate focus area. The following individual segments define the Hermosa Beach walking audit route (Figure 4-1):

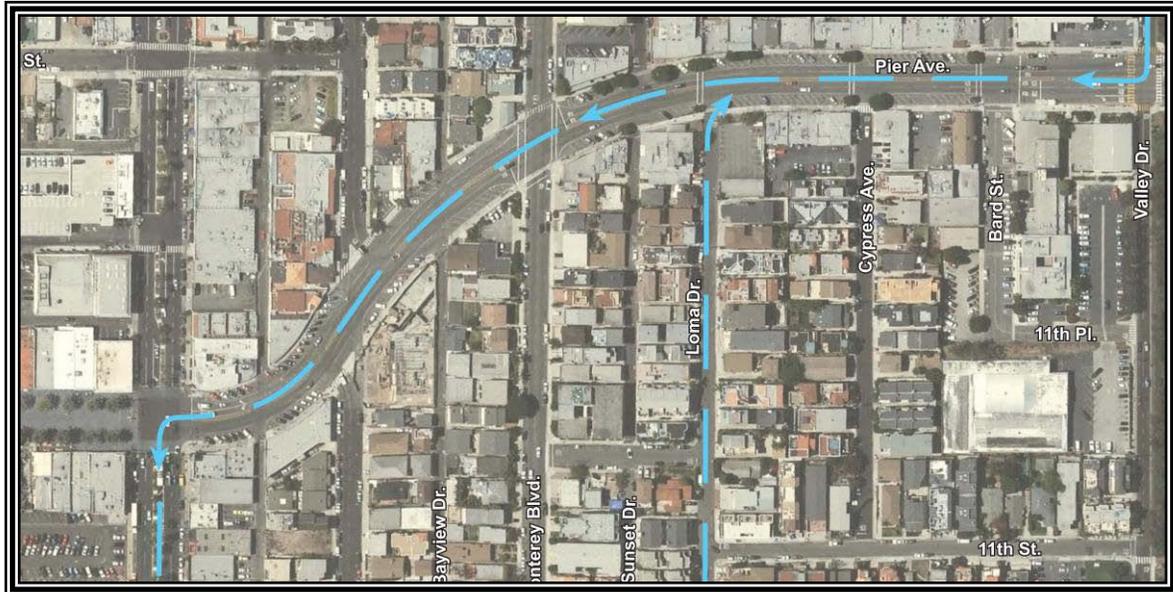
Figure 4-2. Pier Avenue Walking Audit Route Map

The City of Hermosa Beach is currently undergoing a revitalization project for Pier Avenue. Preliminary streetscape improvement plans have been developed for the focus study area and were available to evaluators during the walking audit (Figure 4-3). Therefore, the purpose of the first focus study area was to determine if pedestrian-related improvements could be made to the City's current plans for Pier Avenue. Many of the existing areas for improvement on Pier Avenue were addressed in the streetscape improvement plans.

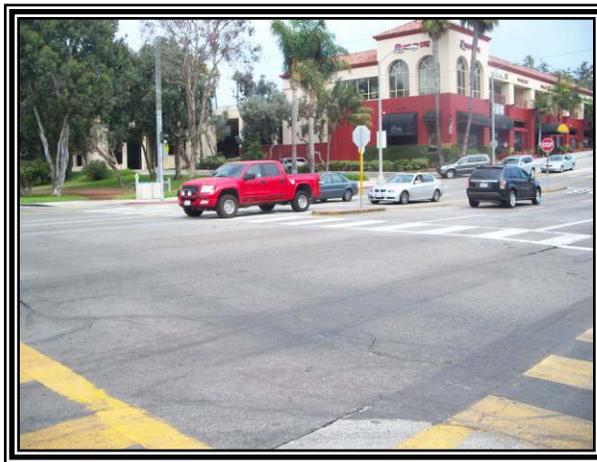
This location is characterized by two closely spaced all-way stop controlled intersections. The closely spaced intersections cause confusion and delay to motorists. The delay is compounded by pedestrian activity crossing Pier Avenue, especially across the multi-use path in the greenbelt, which forms the median between Valley and Ardmore.

Pedestrian access through a roundabout is improved when the approaches to the roundabout are one lane in each direction. The City should strongly consider implementing one lane approaches to any potential roundabout at this location.

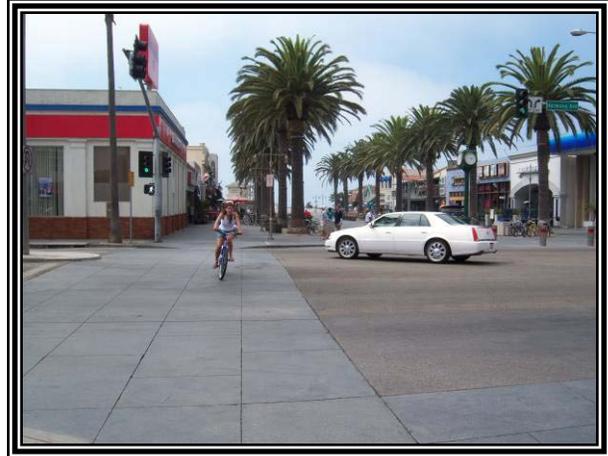
The Pier/Hermosa intersection, which forms the entrance to the City's pedestrian beach area, has the following positive pedestrian features:

- Wide crosswalks
- Textured pavement in the crosswalks

Recommendations:

- Stripe edges of crosswalks and add advanced stop bars
- Increase the size of the bulbouts (on Hermosa Avenue) to tighten the vehicular turning radius
- Provide a leading pedestrian interval for pedestrian signal timings

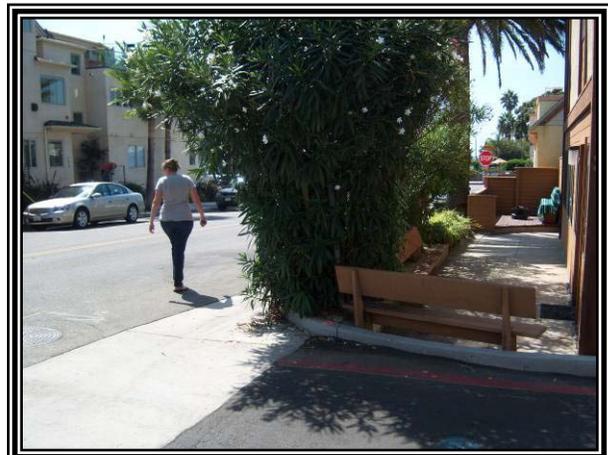
Extra caution should be taken when addressing the issue of private encroachment into public right-of-way. For example, the later recommendation may be seen as tacit approval and granting of public right-of-way to private landowners.

Examples of private encroachment into public right-of-way exist along 8th Street and are all equally obtrusive to pedestrian travel. These recommendations apply to all such instances along 8th Street.

To provide continuous pedestrian facilities along 8th Street, the City of Hermosa Beach should:

- Enforce the City’s right-of-way and prohibit encroachment onto public land, or
- Remove on-street parking adjacent to the patio and create a wide sidewalk which would connect to the existing sidewalk on both sides of the property

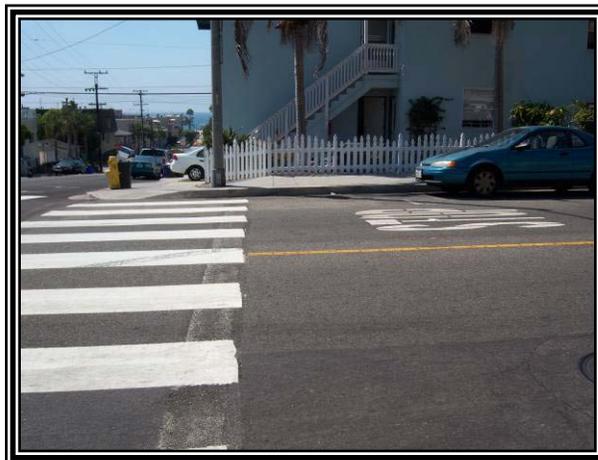
The all-way stop controlled intersection of 8th Street and Manhattan Avenue is characterized by large, continental style crosswalk striping patterns. At this intersection it is recommended to modify the striping to a standard parallel striping pattern (reserving the high visibility striping for uncontrolled crossings) and ensure curb ramps are ADA-compliant.

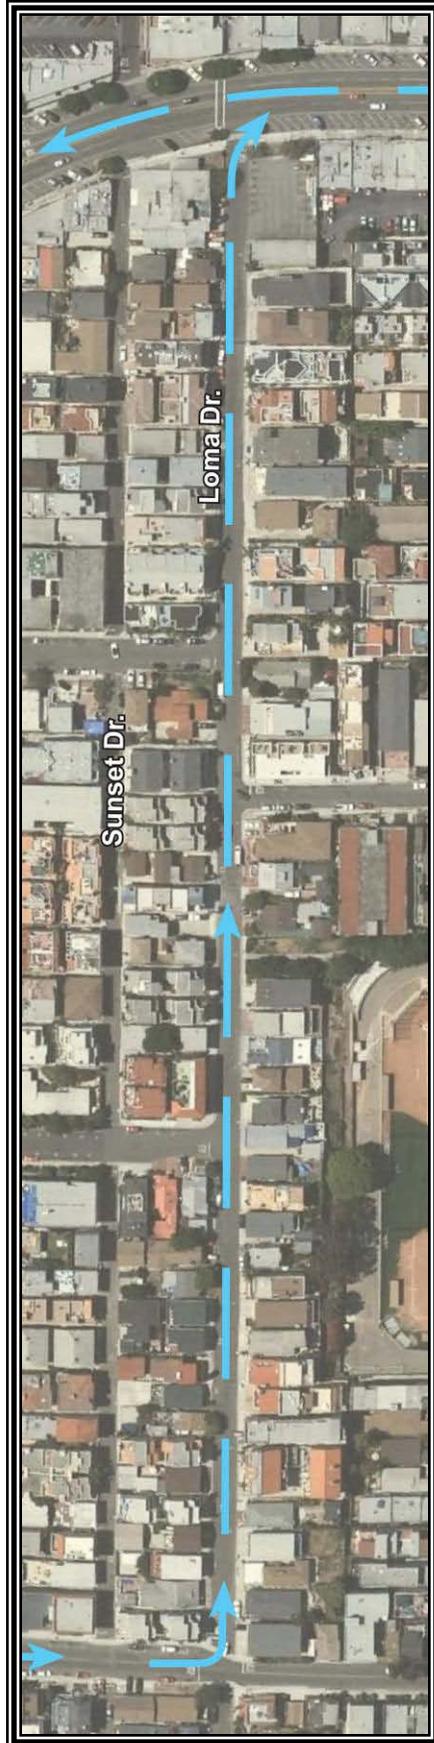
Figure 4-6.
Loma Drive
Walking Audit
Route Map

Two main concerns exist on Loma Drive: private encroachment into public right-of-way and ADA accessible facilities. It is recommended the City work to regain control of the public right-of-way and install sidewalks and ADA accommodations along the entire roadway. It is understandable that this recommendation is a large burden on staff resources, specifically given the relatively low volume of pedestrian activity on the residential roadway. In the interim, the City should consider Loma Drive as a bicycle boulevard, especially given its low volume, low speed nature.

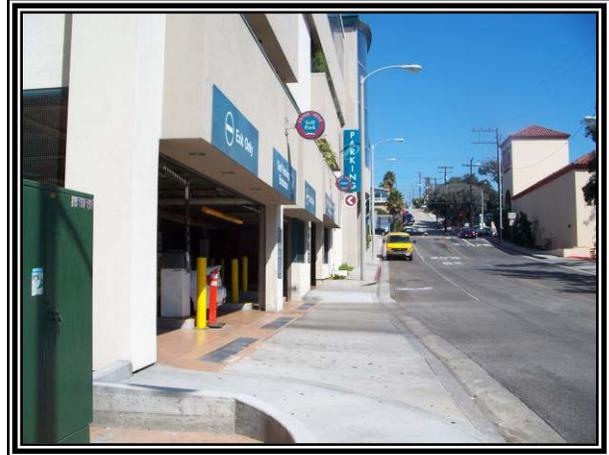
Figure 4-8 presents the walking route for this portion of the walking audit, which traveled east along 16th Street from Ardmore Avenue to the Pacific Coast Highway. Non ADA-compliant driveway cross slopes were the most significant pedestrian accessibility issues found along 16th Street. The City should work with to correct driveway cross slopes and ensure the sidewalks are ADA-compliant.

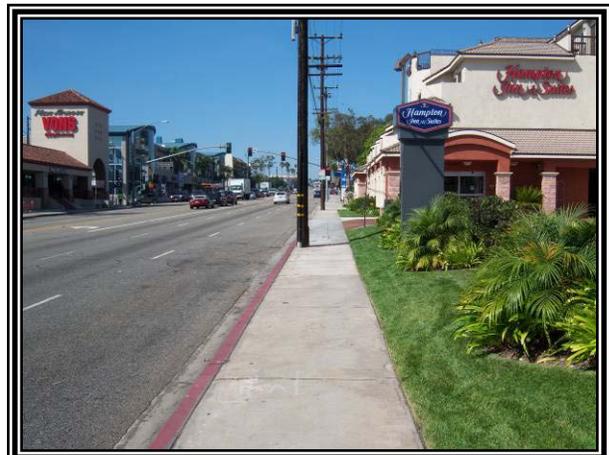
- Narrow sidewalks
- Multiple in-sidewalk obstacles, such as utility poles and sign posts
- Multiple driveway access points
- Driveway cross slope issues

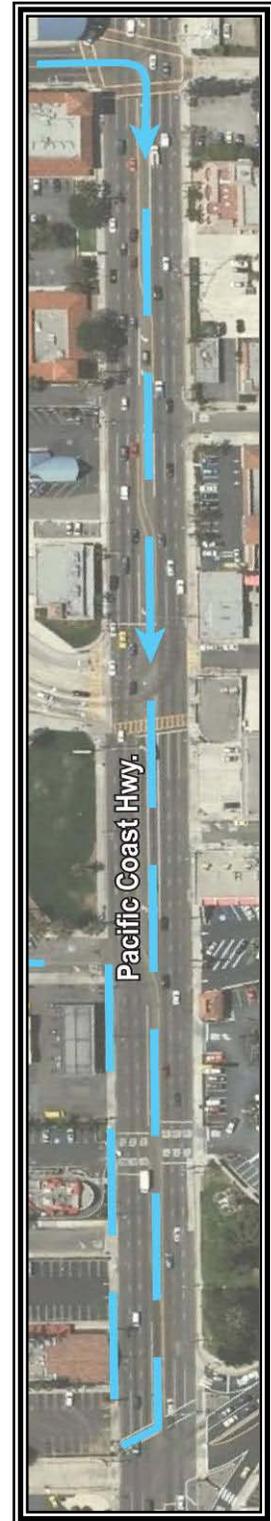
Figure 4-9.
Pacific Coast Highway
Walking Audit
Route Map

Bus stops on the Pacific Coast Highway along the walking audit route were evaluated based on the appropriateness of their locations. It is recommended to work with MTA to relocate the bus stops closer to the signalized intersections of Pier Avenue and Aviation Boulevard. Locating the bus stops close to signalized crossings may reduce the chances of pedestrians crossing the six lane Pacific Coast Highway at a mid-block location.

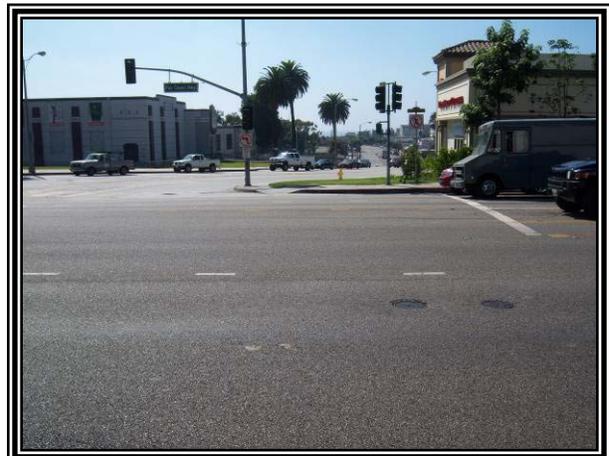
4.10 FOCUS AREA 9: PACIFIC COAST HIGHWAY/PIER AVENUE

- Wide roadway crossing
- Lack of crosswalk on the north side of the intersection
- Large turning radius from the Pacific Coast Highway to Pier Avenue
